Visual Tree Assessment
for Trees that Require Work on Common Land
Urambi Village
Crozier Circuit
Kambah ACT 2902

Report Author	Steve Griffiths Level 5 Arborist Treeworks (ACT/NSW) Pty Ltd
Phone	1800 873 343
Report Date	1 June 2022

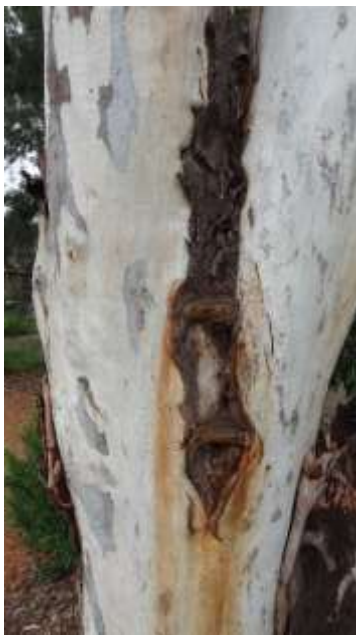
Tree #	Species	Cond	Status (TCCS)	R.O.H.	Recommendations	Priority of Work	Other Information
C1	<i>Eucalyptus mannifera</i>	Fair	Street tree	Medium	Weak base due Phellius sp. fungi at 1m^	Medium	Positioned on street verge near Tree 159. Contact TCCS <i>Fix My Street</i>
C2	<i>Eucalyptus macrorhyncha</i>	Fair	Street tree	Medium	Removal of deadwood at top of tree	Medium	Possible street tree. Contact TCCS <i>Fix My Street</i>
1	<i>Eucalyptus bridgesiana</i>	Good	Regulated	Medium	Removal of deadwood	Medium	This is a large tree
3	<i>Eucalyptus melliodora</i>	Fair	Regulated	Medium	Removal of deadwood	Medium	Near entrance gate
4	<i>Eucalyptus blakeyli</i>	Poor	Non-Regulated	Low	Removal of deadwood, monitor tree health in 12 mths time	Low	Low internode growth evident
5	<i>Eucalyptus melliodora</i>	Fair	Regulated	Medium	Removal of deadwood	Medium	
6	<i>Eucalyptus melliodora</i>	Fair	Regulated	Medium	Removal of deadwood	Medium

Figure 3. C1 Street Tree showing fungal fruiting bodies

Tree #	Common Tree Name	Description of Works	Requires TCCS application	Pricing ex-GST		Method
				Arbor Work	Stump Grinding	
C1	Brittle Gum	Contact "fix my street" (council tree) for approval prior to removal of tree	Yes	\$3,600	\$300	EWP
C2	Stringybark	Contact "fix my street" (council tree) for approval prior to removal of deadwood	Yes	\$500		EWP
1	Apple Box	Deadwood removal	No	\$1,000	-	EWP & Climb
3	Yellow Box	Deadwood removal	No	\$750	-	EWP
4	Red gum	Deadwood removal	No	\$375	-	EWP
5	Yellow Box	Deadwood removal	No	\$1,250	-	EWP
6	Yellow Box	Deadwood removal	No	\$900	-	EWP
7	Red Gum	Monitor tree for lerps in 12 mths	No	-	-	Ground
18	Tree Stump	Stump grinding	No	-	\$320	Stump grinder
26	Peppermint Gum	Remove Tree	No	\$570	\$300	EWP
28	Red Box	Pruning	No	\$470	-	Climb
42	Black wattle	Deadwood removal	No	\$470	-	Ground
56	Desert ash	Tree Removal	Yes, requires TCCS approval	\$2,400	\$420	Climb
59	Brittle Gum	Deadwood removal	No	\$470	-	EWP

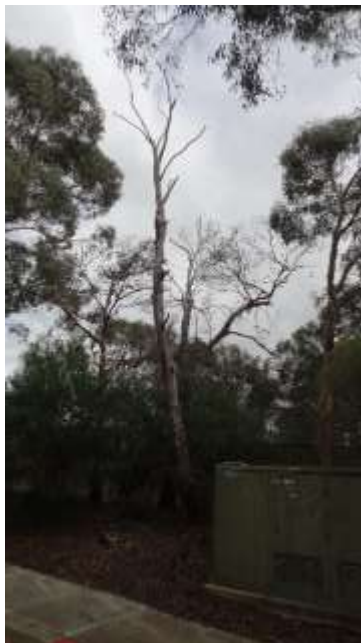
Figure 5. Tree 188 (3 dead trees)

Tree #	Common Tree Name	Description of Works	Requires TCCS application	Pricing ex-GST		Method
				Arbor Work	Stump Grinding	
145	Argyle Apple	Cover exposed roots with mulch (advised)	No	-	-	Ground
147	Peppermint Gum	Pruning	No	\$500	-	EWP
151	Candle bark	Deadwood removal	No	\$500	-	EWP
152	Candle bark	Deadwood removal and pruning	No	\$500	-	EWP
159	She oak	Deadwood removal	No	\$200	-	Climb
162	She oak	Deadwood removal	No	\$400	-	EWP
166	Argyle apple	Lift canopy, clear building and re-tie bird box	No	\$700	-	EWP
170	Broad leaf ironbark	Selective weight reduction by 15% and remove deadwood	No	\$760	-	EWP
171	X4 medium gums	4 trees growing as one. Remove deadwood	No	\$1,000	-	EWP
172	Slippery Elm	Lift and clear unit 69	No	\$500	-	Climb
178	Ribbon Gum	Removal of deadwood and pruning	No	\$470	-	EWP
181	Brittle Gum	Deadwood removal	No	\$470	-	EWP
185	Gum Tree	Deadwood removal	No	\$470	-	EWP
188	(x3) Dead Gums	Removal of (x3) small trees and grind stump	No	\$470	\$300	EWP

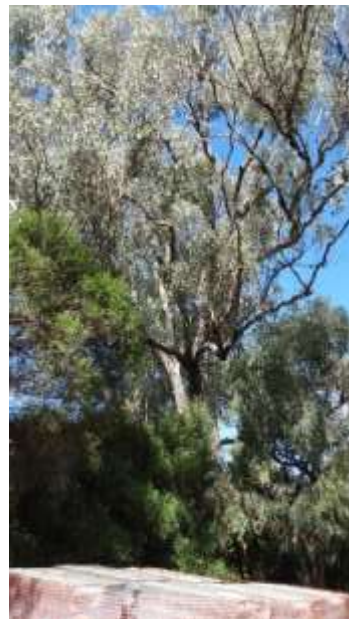
Figure 7. Tree 123 - one of the many remnant trees on site

112	<i>Eucalyptus bridgesiana</i>	Good	Regulated	Medium	Removal of deadwood and aerial inspection recommended	Medium	Large tree
115	(x2) <i>Eucalyptus macrorhyncha</i>	Good	Non-Regulated	Low	Removal of deadwood on both trees	Low	
123	<i>Eucalyptus bridgesiana</i>	Good	Regulated	Medium	Removal of deadwood and aerial inspection recommended	Medium	Large tree
129	Melaleuca sp.	Fair	Non-Regulated	Low	Repair storm damaged branches	Low	
133	(x3) <i>Eucalyptus polyanthemos</i>	Fair	Regulated	Low	Removal of deadwood on all 3 gum trees	Low	Possible Golf course tree
134	Melaleuca sp.	Good	Non-Regulated	Low	Clear branches from building	Low	
136	<i>Eucalyptus viminalis</i>	Fair	Regulated	Medium	Removal of deadwood	Medium	Possible Golf course tree
141	<i>Eucalyptus nicholli</i>	Fair	Regulated	Medium	Monitor tree (advised)	Medium	Monitor tree health in 12mths time
145	<i>Eucalyptus cinerea</i>	Good	Regulated	Low	Cover exposed roots (advised)	Low	Require 4m ³ of course mulch to cover roots

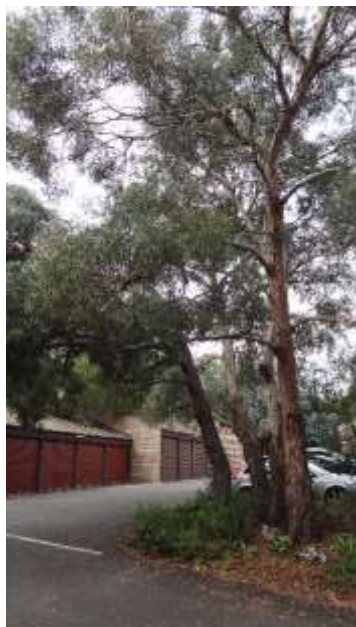
Figure 4. Trees 171 encroaching over driveway

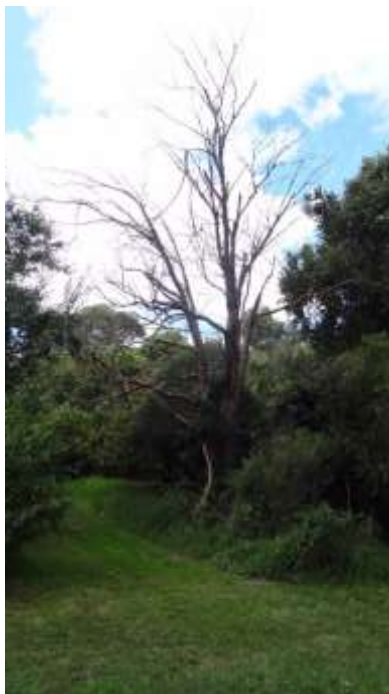
7	<i>Eucalyptus blakeyli</i>	Fair	Non-Regulated	Low	Monitor this tree is 12mths time for Psyllid (lerps) infestation	Low	5 years of constant attack from Psyllids may kill the tree. Can be treated with stem injection of imidacloprid.
18	Stump only	-	Non-Regulated	Low	Grind this stump	Low	Possible trip hazard
26	<i>Eucalyptus nicholli</i>	DEAD	Non-Regulated	Medium	Remove tree and grind stump	Medium	
28	<i>Eucalyptus polyanthemus</i>	Good	Regulated	Medium	Removal of deadwood	Medium	
42	<i>Acacia decurrens</i>	Fair	Non-Regulated	Low	Removal of deadwood and remove storm damaged branches	Low	Tree has short life expectancy less than 10 yrs

Figure 6. Tree 26 – dead tree

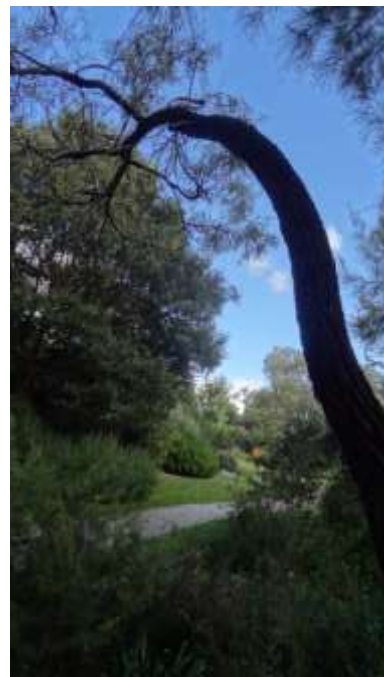
Figure 8. Tree 95 – heavy lean over footpath

84	Yellow Box	Deadwood removal	No	\$1,500	-	EWP & Climb
95	Ironbark gum	Tree removal	No	\$850	\$200	Ground
101	Peppermint Gum	Removal of deadwood and pruning	No	\$670	-	Climb
106	Peppermint Gum	Deadwood removal	No	\$470	-	EWP
112	Apple box	Deadwood removal and aerial inspection	No	\$1,000	-	EWP
115	(x2) Red stringy bark	Deadwood removal	No	\$870	-	Climb
123	Argyle apple gum	Deadwood removal and aerial inspection	No	\$1,350	-	EWP & Climb
129	Paperbark	Pruning	No	\$570	-	Climb
133	(x3) Red Box	Deadwood removal	No	\$560	-	EWP
134	Paperbark	Pruning	No	\$470	-	EWP
136	Candle bark gum	Deadwood removal	No	\$560	-	EWP
141	Peppermint Gum	Monitor in 12 mths time	No	-	-	Ground

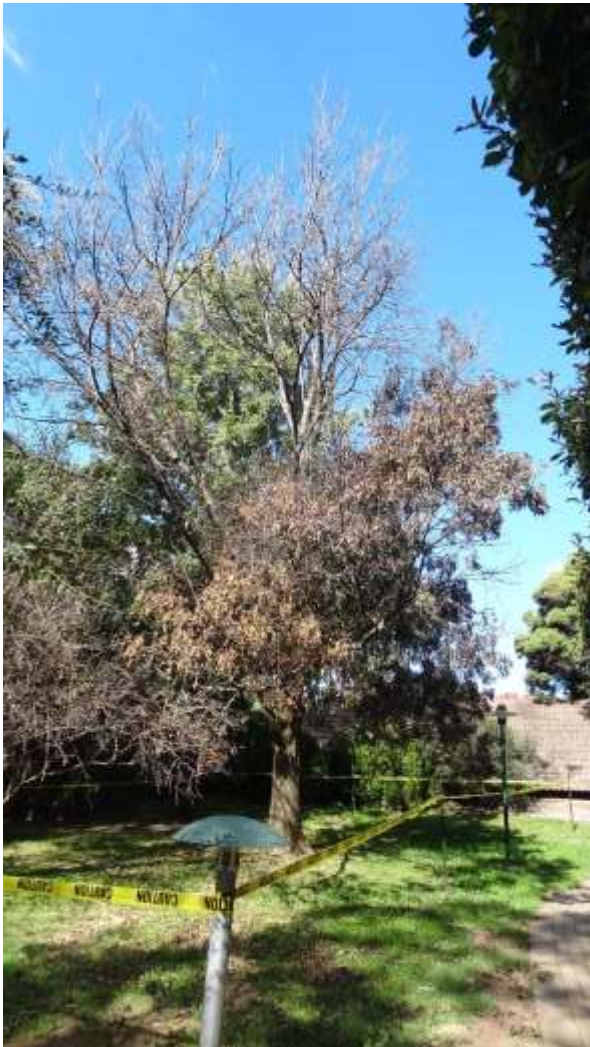
Tree #	Species	Cond	Status (TCCS)	R.O.H.	Recommendations	Priority of Work	Other Information
56	<i>Fraxinus oxycarpa</i>	Poor	Regulated	Medium	In spiral decline. Remove this near dead tree and grind stump	Medium	Reason for death of tree is possible Phytophthora sp. due to heavy clay soils creating poor drainage.
59	<i>Eucalyptus mannifera</i>	Fair	Regulated	Low	Removal of deadwood and monitor bird damage	Low	Tree is opposite unit 39
84	<i>Eucalyptus melliodora</i>	Fair	Regulated	Medium	Removal of deadwood	Medium	Large yellow box
95	<i>Eucalyptus sideroxylon</i>	Fair	Non-Regulated	High	Remove this small to medium sized tree and grind stump. Tree has short life expectancy	High	This tree has lean over pathway in front of unit 29.
101	<i>Eucalyptus nicholli</i>	Fair	Regulated	Low	Removal of deadwood and clear building	Low	
106	<i>Eucalyptus nicholli</i>	Fair	Non-Regulated	Low	Removal of deadwood	Low

Figure 9. Tree 56 in spiral decline – remove this nearly dead tree
